SERVICE BULLETIN

Date: July 10, 2018
Update Number: S2018-02
Subject: Trolley Service Kit K75-39337
Products Affected: LiftMaster® Models LA500DC, LA500DCS

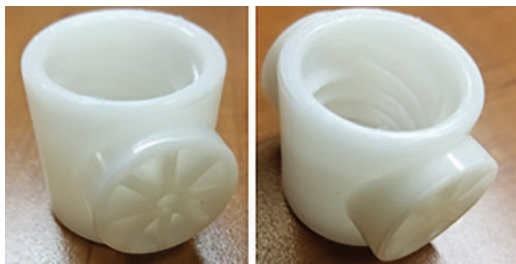
The travel nut on LA500DC and LA500DCS gate operators may break when excessive force is applied to the gate, such as being struck from a vehicle. The travel nut can be identified as the white plastic nut that attaches to the internal lead screw of the arm. The symptom of this problem is that the trolley assembly slides back and forth along the guide slots without mechanical restraint. The broken part can be observed through the guide slots on the bottom of the arm.

LiftMaster has created Trolley Service Kit K75-39337 with all the necessary parts and provides instructions on how to replace a damaged travel nut within an LA500 arm. LiftMaster advises the travel nut replacement to be conducted in a controlled environment such as on a bench in a workshop, due to its complexity and the opportunity of dirt/debris being trapped within the transmission of the arm.
