PRODUCT BULLETIN

Date: Oct 07, 2019
Update Number: P2019-26
Subject: CAPXL Updated Firmware Release v1.28
Product Affected: CAPXL

Type of Change: 1.28 Firmware Release for CAPXL

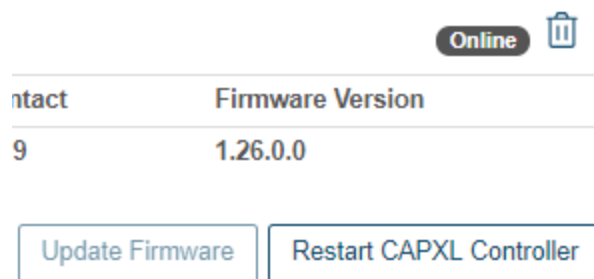
Figure 1: update firmware button screen shot from Controllers screen

4. Click the "Update Firmware" button.
 - a. **Press the button only once.** Repressing the upgrade button may restart the process resulting in longer upgrade times
 - b. A confirmation message will appear and the CAPXL will immediately begin downloading the new firmware and will automatically perform a restart. After the restart, the CAPXL will maintain its previous settings and resident database. After the restart is complete, it will show as Online and the Update Firmware button will no longer be active.
