# PRODUCT BULLETIN

**Date:** February 27, 2019  
**Update Number:** P2019-07  
**Subject:** CAPXL Updated Firmware Release v1.26  
**Product Affected:** CAPXL

## **Type of Change: 1.26 firmware release for CAPXL**

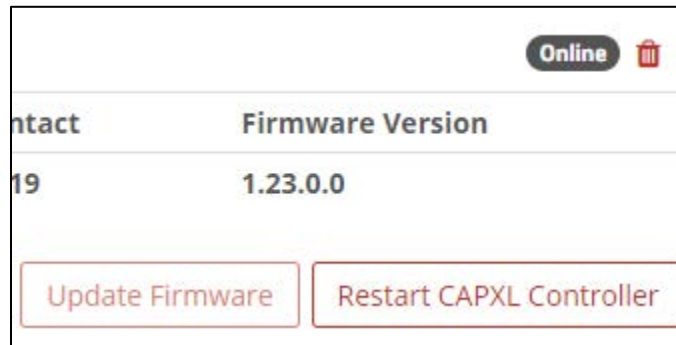
3. Confirm the CAPXL is online and confirm the “Update Firmware” button is available

Figure 1: update firmware button screen shot from Controllers screen

4. Click the “Update Firmware” button.
  - a. A confirmation message will appear and the CAPXL will immediately begin downloading the new firmware and will automatically perform a restart. After the restart, the CAPXL will maintain its previous settings and resident database. After the restart is complete, it will show as Online and the Update Firmware button will no longer be active.
